**FBI Laboratory**2501 Investigation Parkway
Quantico, Virginia 22135**LABORATORY REPORT**

Title: Explosion Investigation at Maldives;
Foreign Police Cooperation-
Technical Assistance Request

THE FOLLOWING ITEMS WERE RECOVERED FROM THE MALDIVIAN GOVERNMENTAL VESSEL, THE FINIFEMA. AN EXPLOSION OCCURRED ON SEPTEMBER 28, 2015 ON THIS VESSEL IN THE HARBOR OF MALE, THE MALDIVES. THESE ITEMS WERE SUBMITTED UNDER COVER OF COMMUNICATION DATED OCTOBER 28, 2015, RECEIVED INTO THE LABORATORY ON OCTOBER 22, 2015 AND OCTOBER 27, 2015 AND ASSIGNED LABORATORY NUMBER 2015-02440.

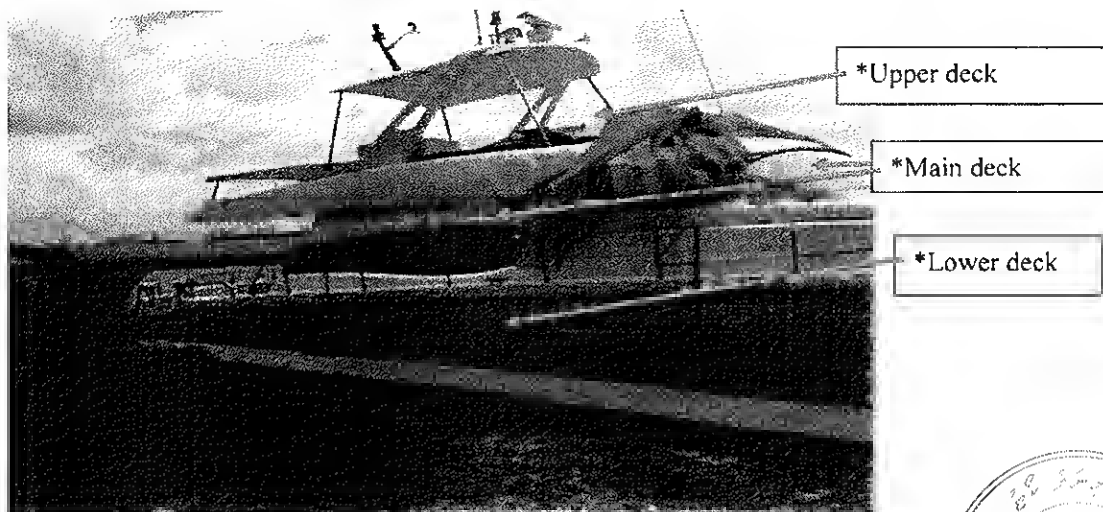
Figure 1

On September 28, 2015 an explosion occurred on an official Maldivian government boat (Figure 1) carrying the President of the Maldives and his entourage. The United States was asked to assist in the investigation of the explosion. The FBI Explosives Unit along with other FBI personnel conducted a post blast investigation on the boat.

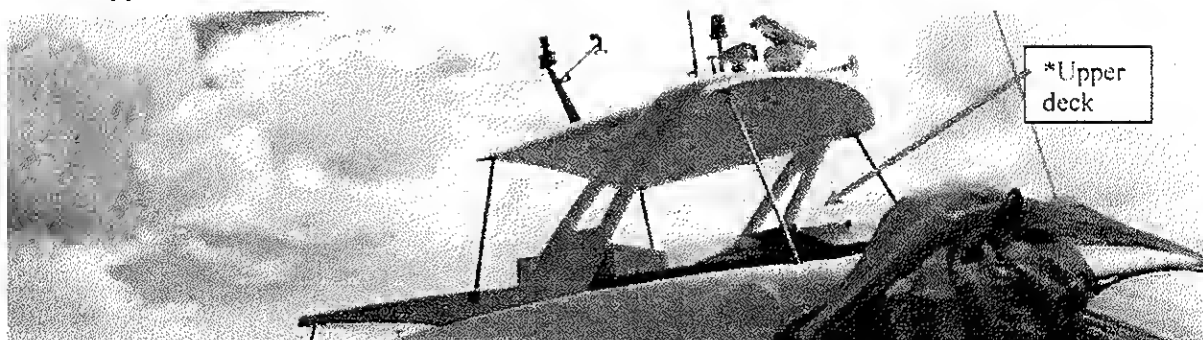
Figure 2 shows the upper deck level, outside bridge area which sustained no damage from the blast.

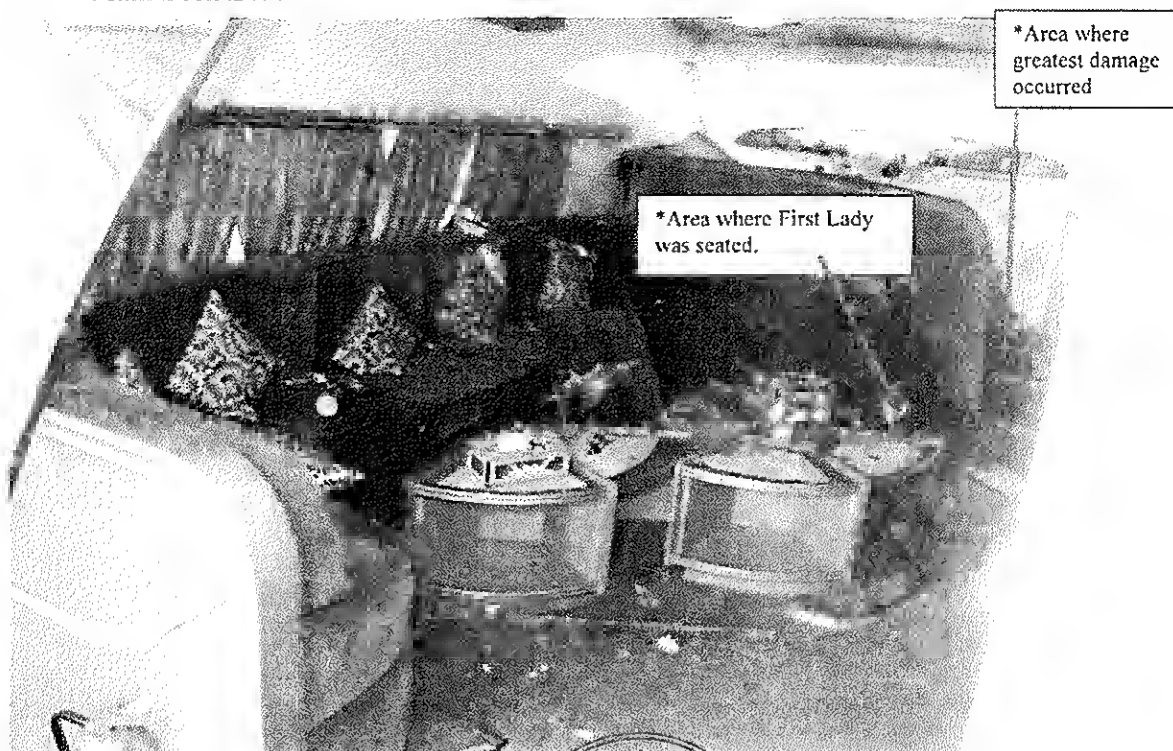
Figure 3

The First Lady was sitting on the couch as noted in figure 3 and figure 4, directly aft of the wall where the area of greatest damage occurred. She sustained several fractured vertebrae when the overpressure from the explosion threw her forward over the coffee table. Other injuries to personnel on the boat were reported as being minor.

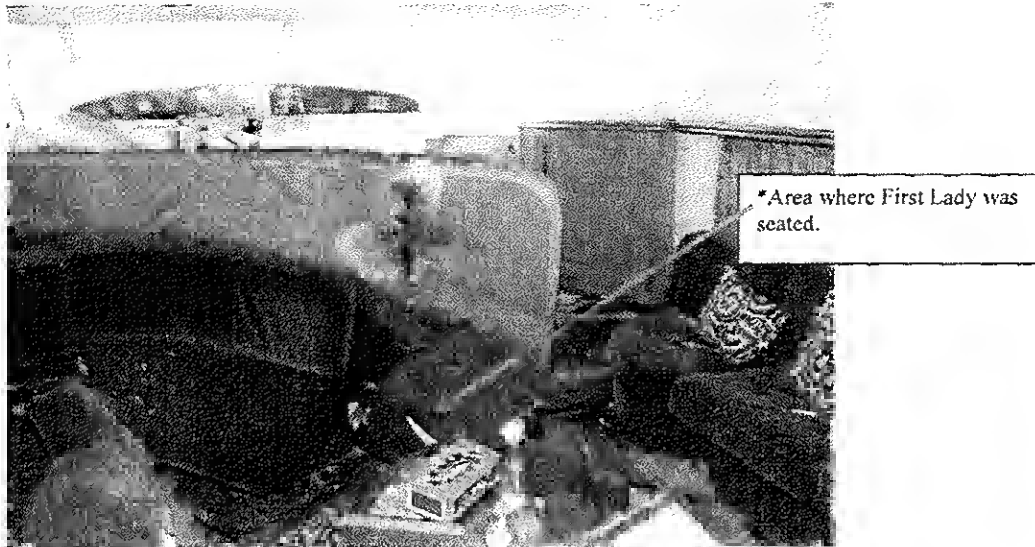
Figure 4

The main deck is the level where the explosion occurred, causing damage to the interior seating area and the box seat in the bridge area. The explosion damaged the half-wall between these two areas. No windows were shattered or broken during the blast. The rear sliding glass door was pushed off of its tracks and one window in the hridge area of the boat was slightly pushed out of its frame.

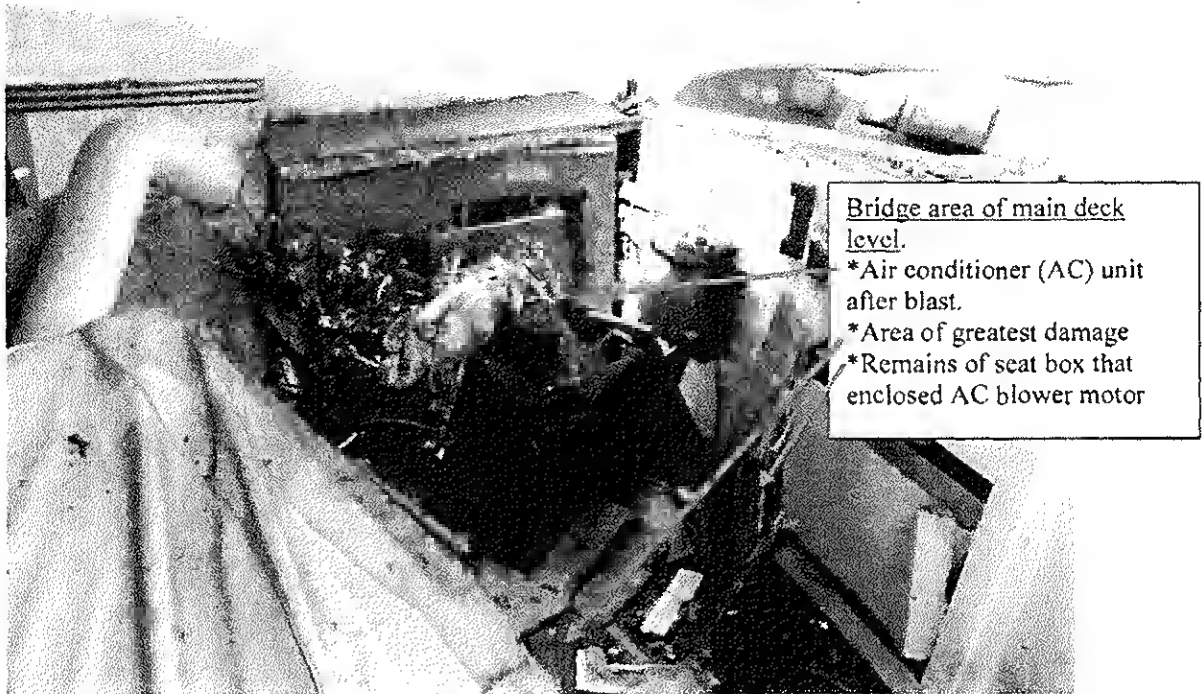
Figure 5 shows the area where the greatest damage occurred, located on the main deck level in the bridge area. The seat box that enclosed the air conditioner (AC) blower motor was destroyed by an explosion originating from within its interior. The AC unit was pushed up and sustained damage to its base plate frame and the fan motor housing. The flexible aluminum exhaust tube was destroyed.

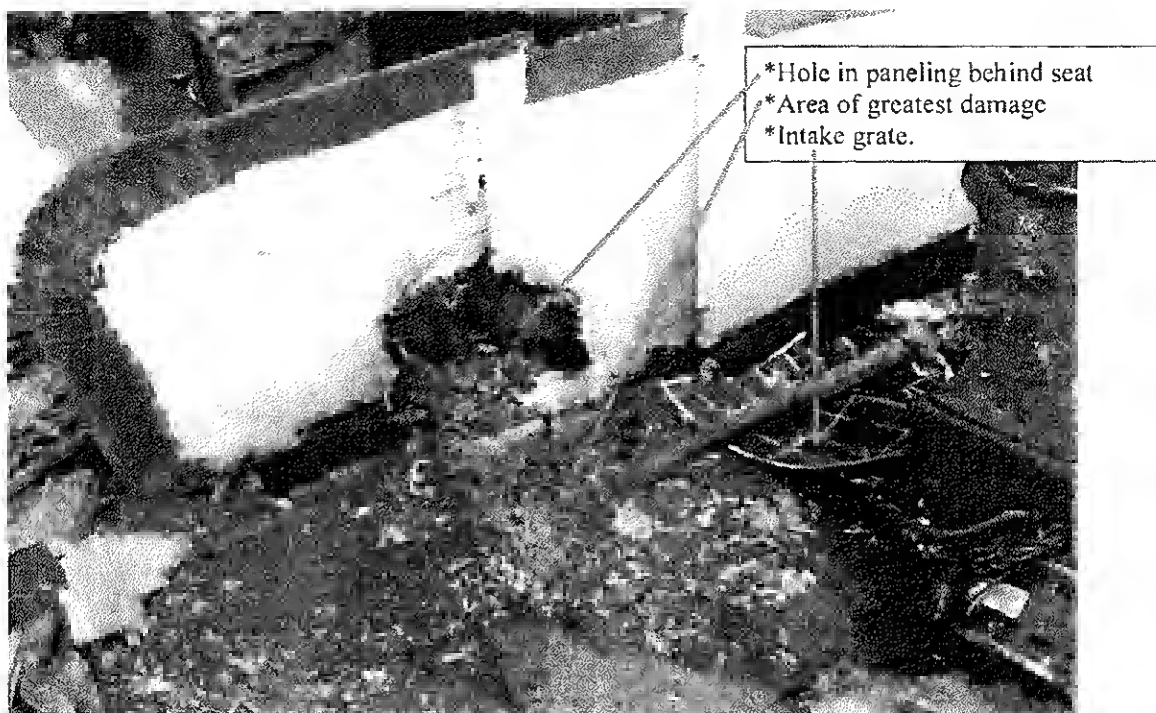
Figure 7

Shown in figure 7 is the area of greatest damage on the boat. As depicted in this photo, the wood paneling had been removed from the seat to expose the hole created by the overpressure. The intake grate, which was attached with screws to the box seat, allowed air to be taken in by the blower motor (see figure 13 for approximate location of the intake grate). This grate exhibited damage of being pushed outward from the seat by the overpressure from the explosion.

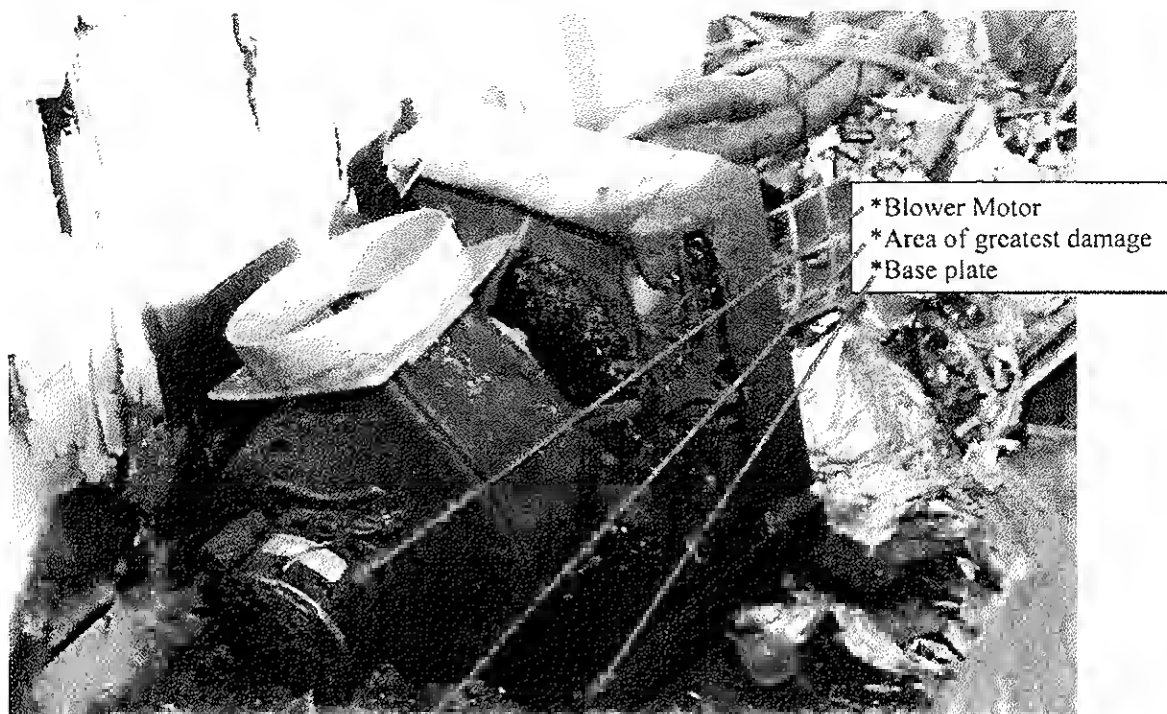
Figure 8 shows the blower motor and the base plate in the approximate location where they would have been before the explosion. Soot was visible on the blower motor and fan casing. (See figure 13 for further detail)

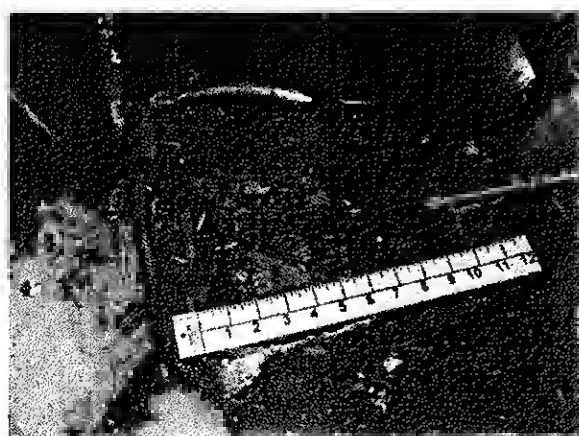
Figure 9 shows the area of greatest damage and the red arrow is pointing to the main support beam which has no visible damage.

Figure 9 and figure 10 show the approximate size of the area of greatest damage. The approximate size of damage to the floor is 9" long x 10" wide. Figure 11 shows the thickness of the floor, which was 1/2" plywood, and the spacing between the floor and the ceiling of the galley below, which was approximately 2 inches. There was no penetration of the galley ceiling from overpressure nor from fragmentation of the subfloor above.

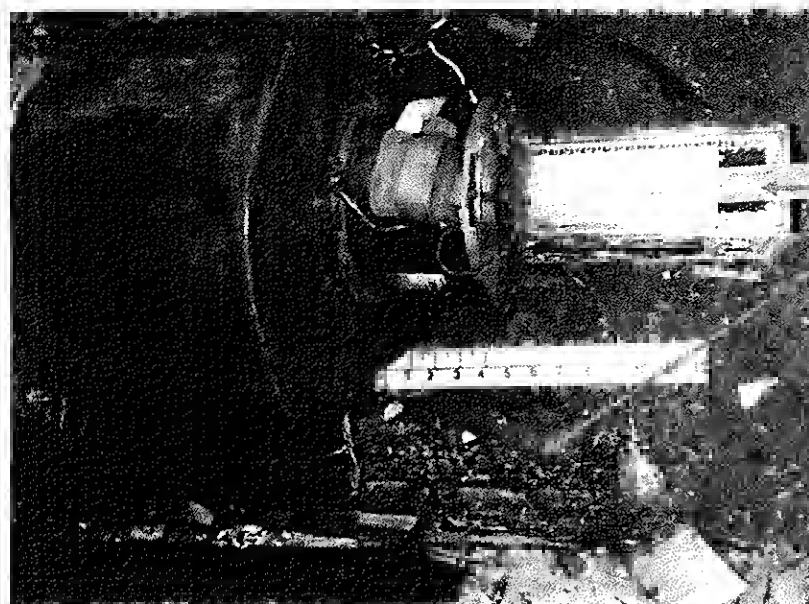
- *Facial tissue box
- *No damage to ceiling.

Figure 10 shows a facial tissue box utilized to support the blower motor for demonstration of its location. The area below the ruler shows that no damage occurred to the ceiling of the galley, even though this area is only approximately 2 inches below the area of greatest damage.

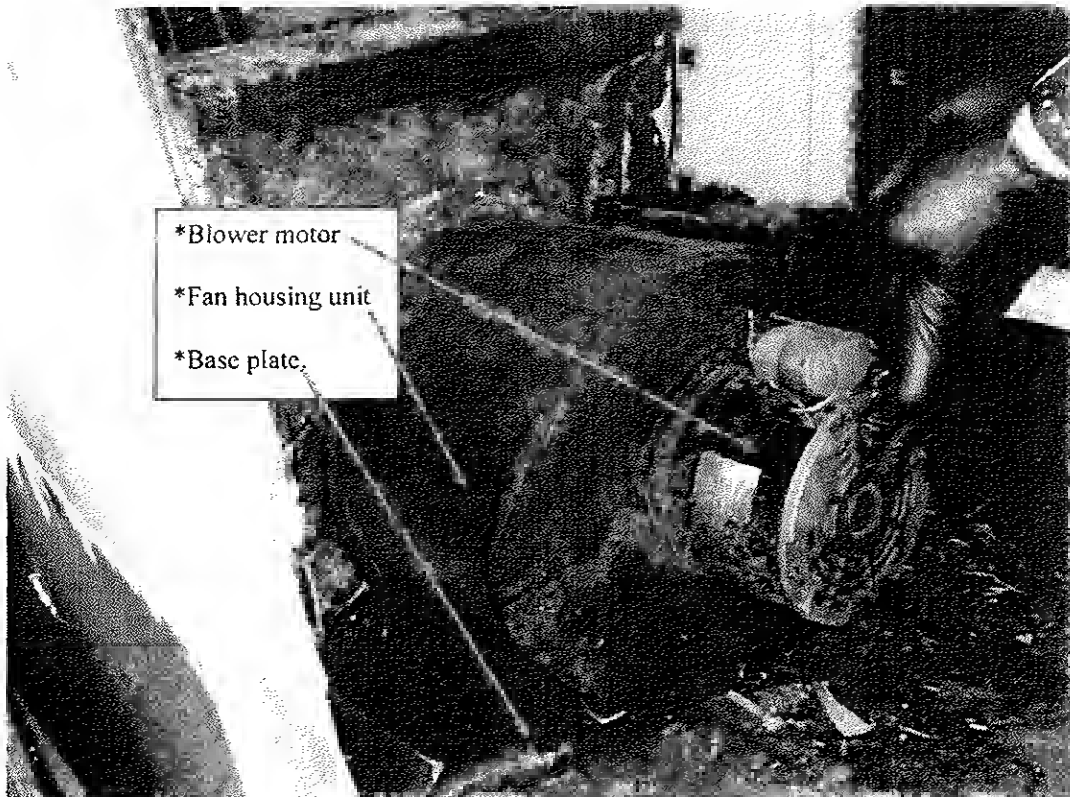
Figure 12 shows damage to the base plate and fan housing unit.

Item 25 consisted of a metal base plate or tray that had the blower motor, fan unit and radiator sitting on it. This plate had damage consistent with being in close proximity to an explosion.

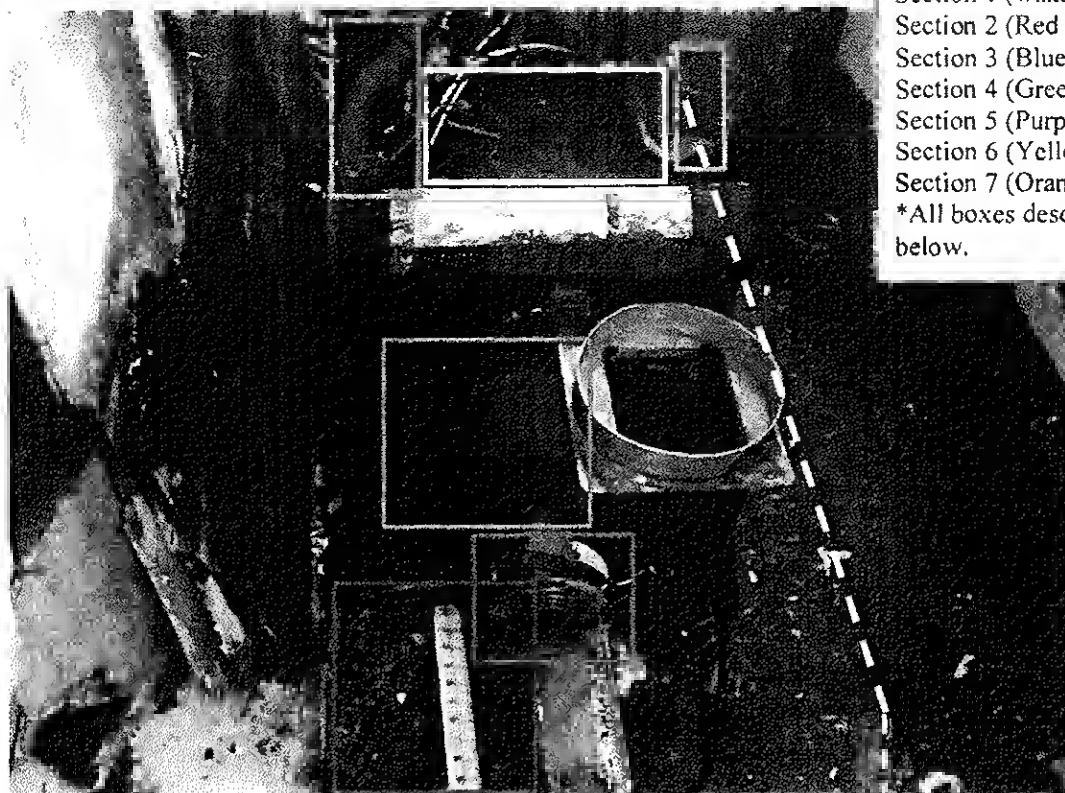
Figure 13 shows an overview of how the air conditioner unit was located under the box seat area. The white line (section 1) is an approximate outline of the outer wall of the box seat that covered the air conditioning unit. The red box (section 2) indicates the black insulation covering two copper coolant lines that carried refrigerant from a storage tank to the air conditioning unit and back. The blue box (section 3) indicates the fan housing unit that sustained damage (see figure 12 for closer view of damage) from the blast. The green box (section 4) indicates the fan motor. The purple box (section 5) indicates the area of greatest damage. The yellow box (section 6) is where cleaning chemicals purportedly were stored along with other chemicals used on the boat for various maintenance purposes. To gain access to this area, screws would have to be removed from the lid of the box seat or the air intake grate. The approximate location of the air intake grate is indicated by the orange box (section 7).

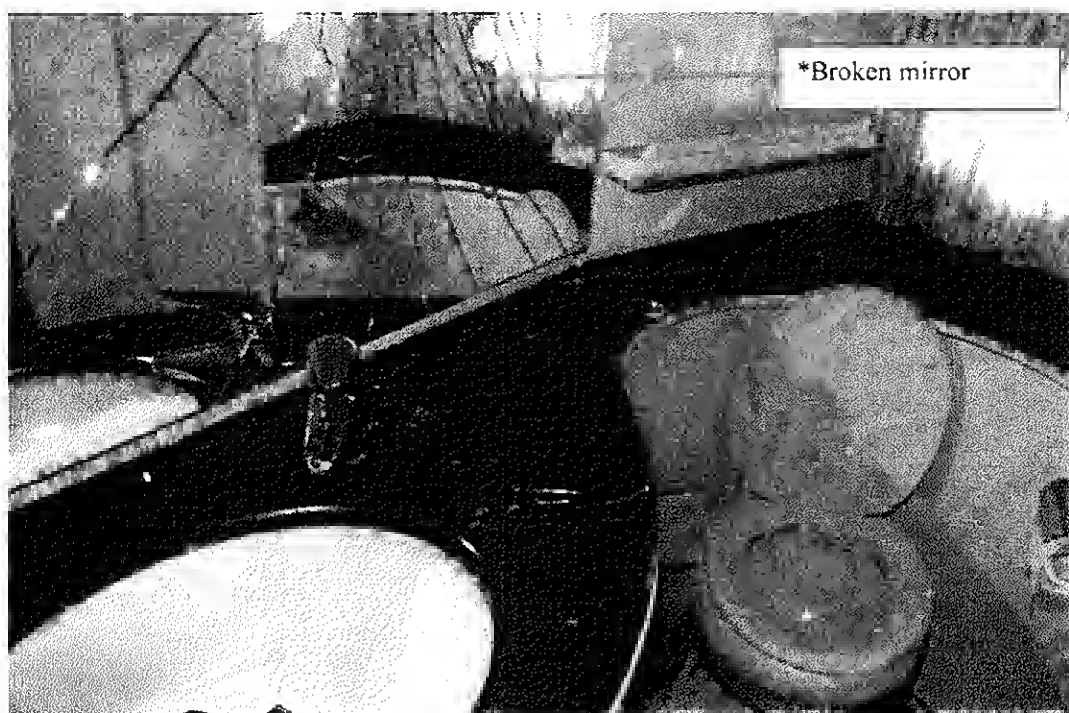
The lower deck directly below the area of greatest damage on the main deck sustained minimal damage; a broken mirror in the bathroom, (figure 14) and broken wood in the galley (figure 15).

Figure 14 shows the broken mirror in bathroom on the lower deck. This bathroom was located directly at the bottom of the stairs below the area of greatest damage.

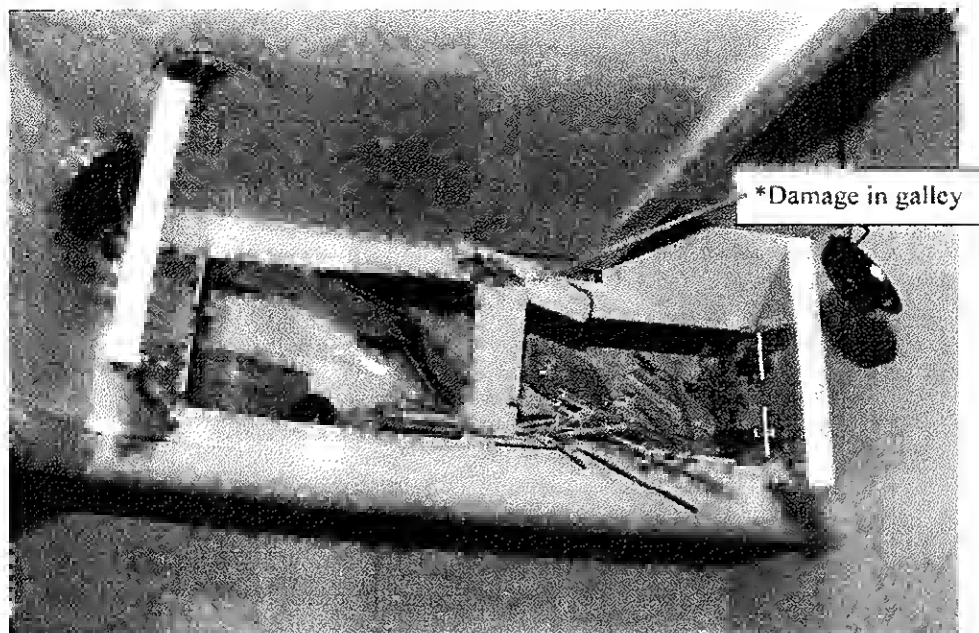
Figure 15 shows the damage to the wood cabinet in the galley. There was no penetration of the ceiling from the area of greatest damage above.

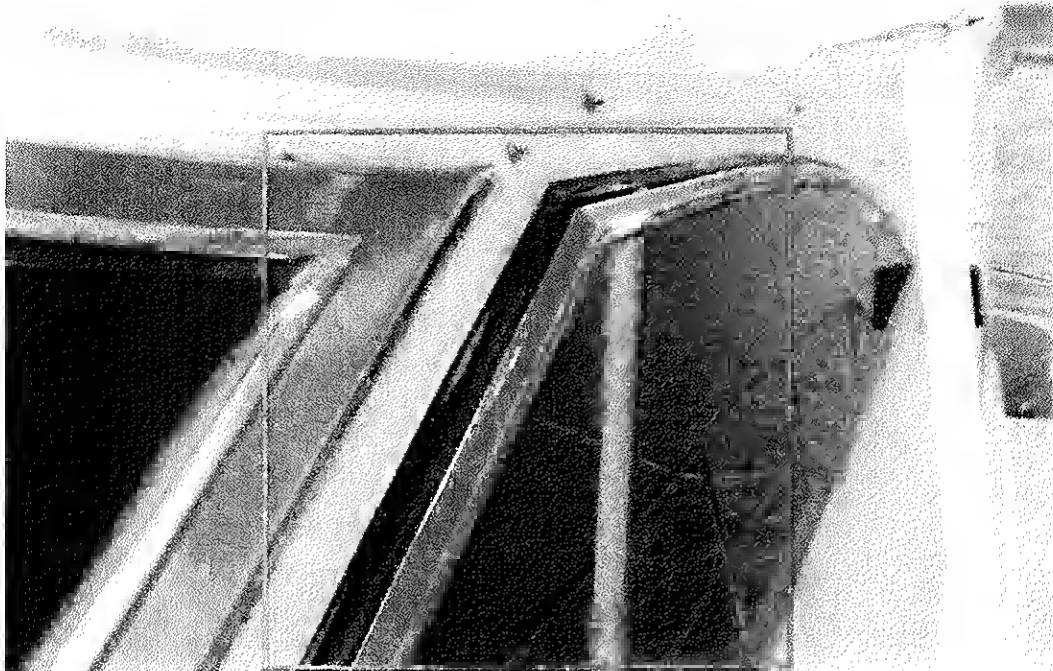
Figure 16

The exterior of the boat had no visible damage except a port side window (shown in the red box in figure 16) that was slightly pushed out from its frame due to the blast.
